Geotechnical Challenges of TTEAS

Chambers Wharf - Panel 15 Collapse & Recovery Works

Chambers Wharf – Panel 15 – 9th March 2018

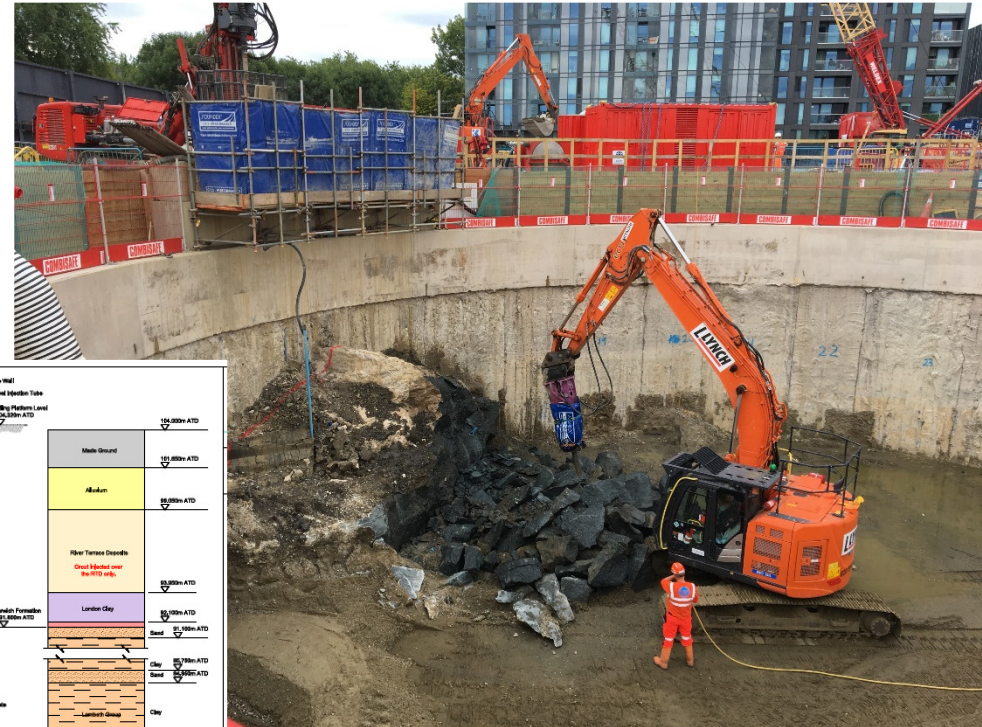
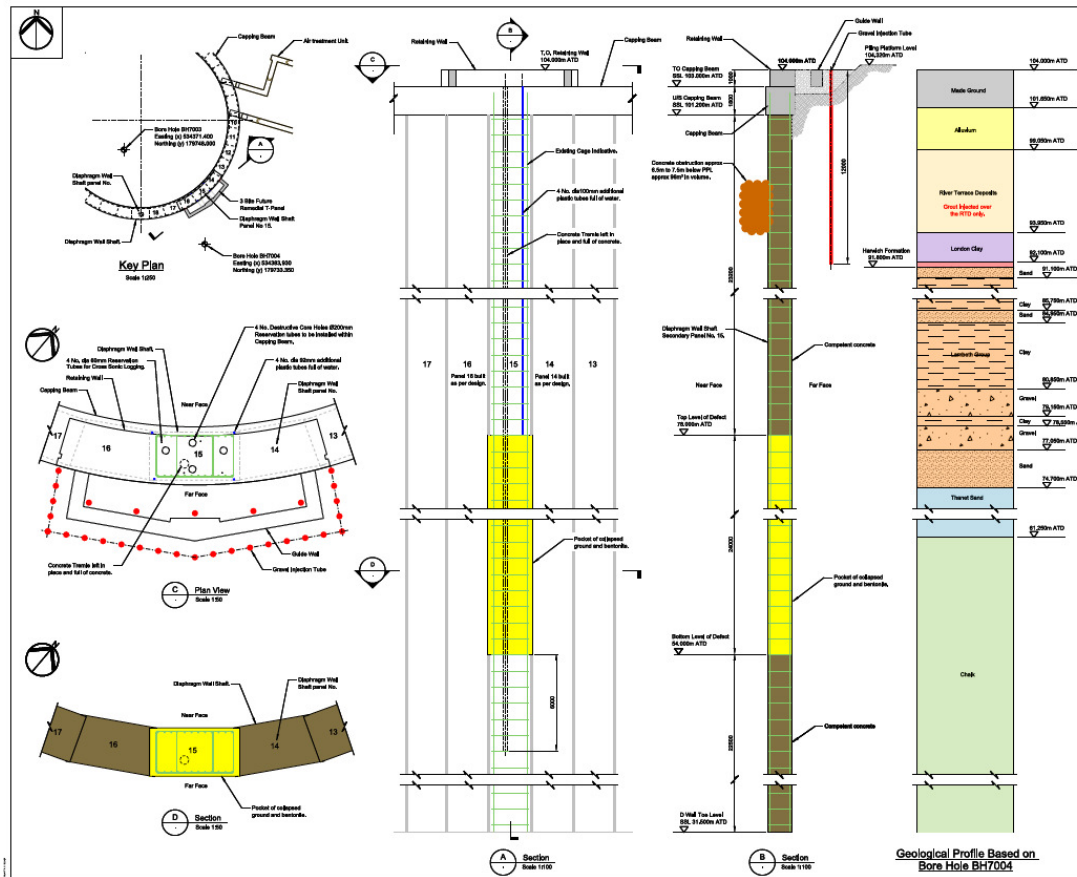
Collapse of c. 95m³ of RTDs into penultimate panel during concreting process

RTDs had been permeation grouted prior to dwelling based on experience during preceding chalk grouting works drilling

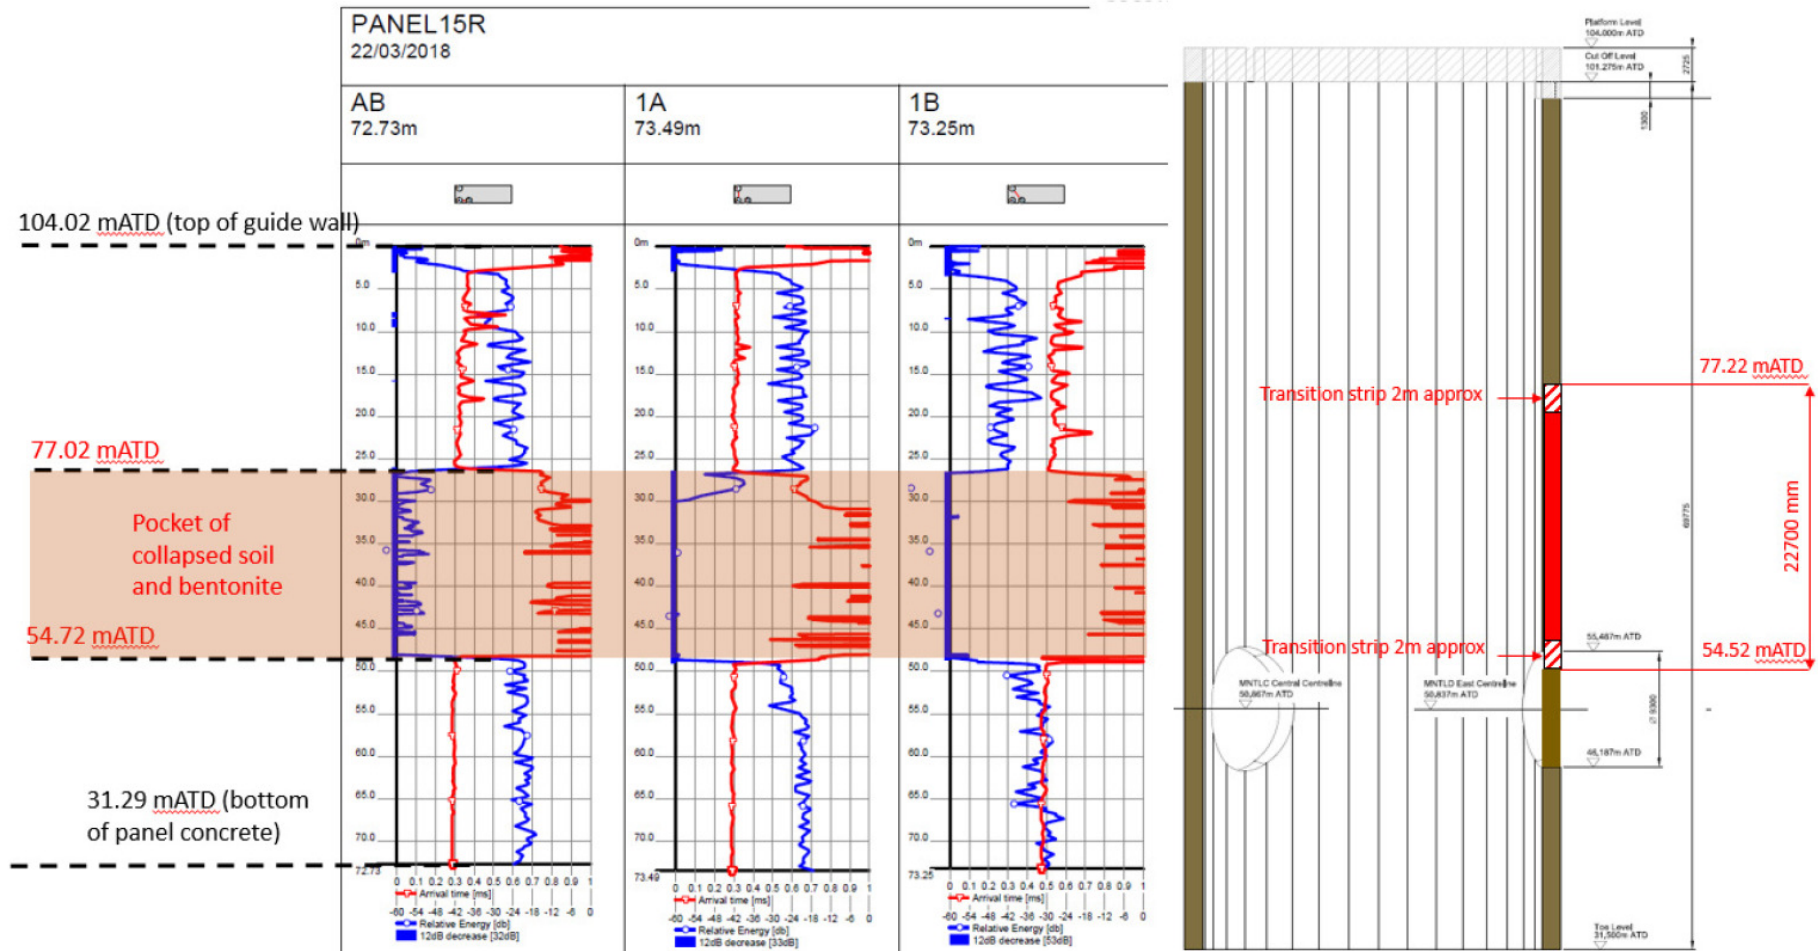
Chambers Wharf – Panel 15 – Evidence of the Problem

77mATD to 54mATD inc Lower Lambeth Group / Thanet Sand / Upper Chalk

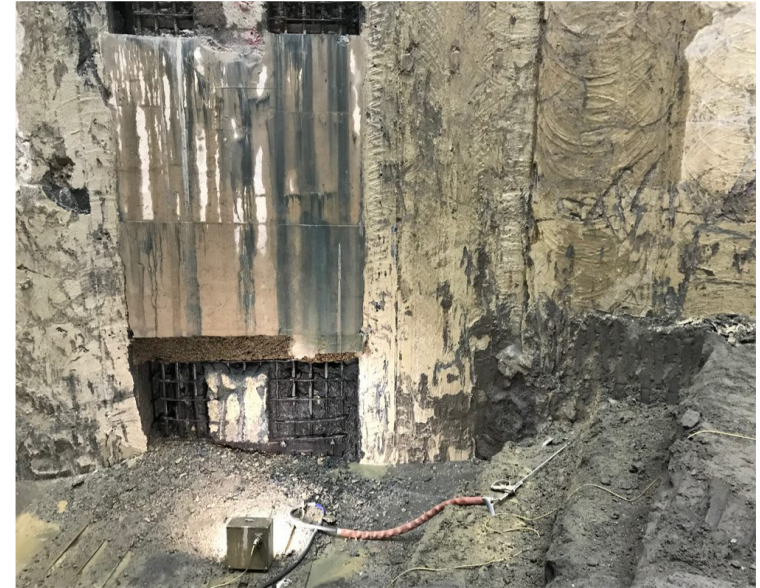
Repaired concrete
at 69mATD

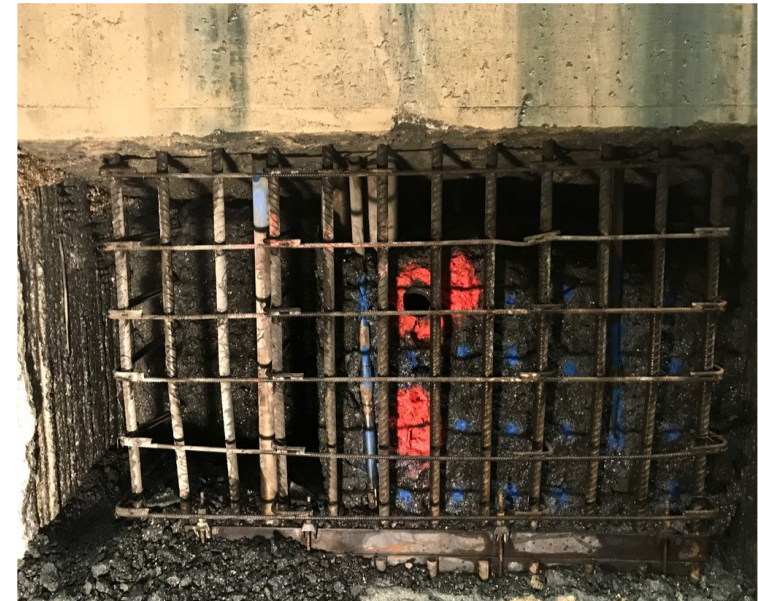
Hydrodemolitioned
concrete at 67.5mATD

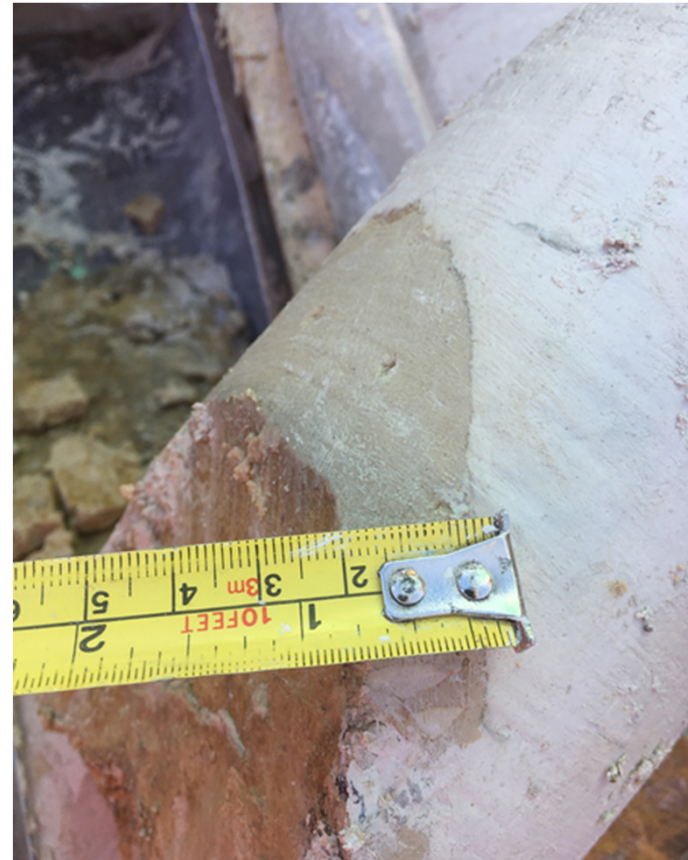
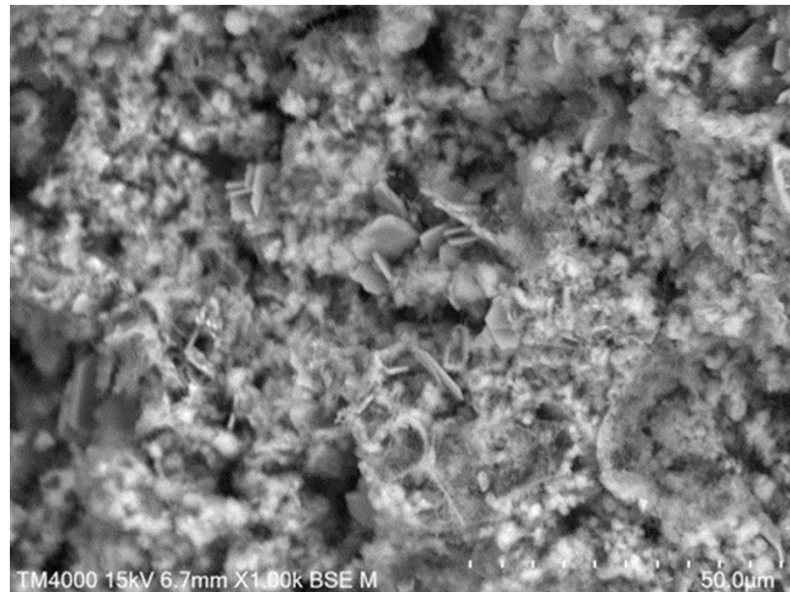
- Infill observed in two fractures at projected levels of fissure
- Material described as firm cream silt/clay
- Imperial College sample comparisons, physical observations and SEM analysis.
- CVB and IC labs in agreement that the material was most likely grout

SEM Images at x1000 magnification shows the fissure in-fill material to have the same characteristics as the grout sample.

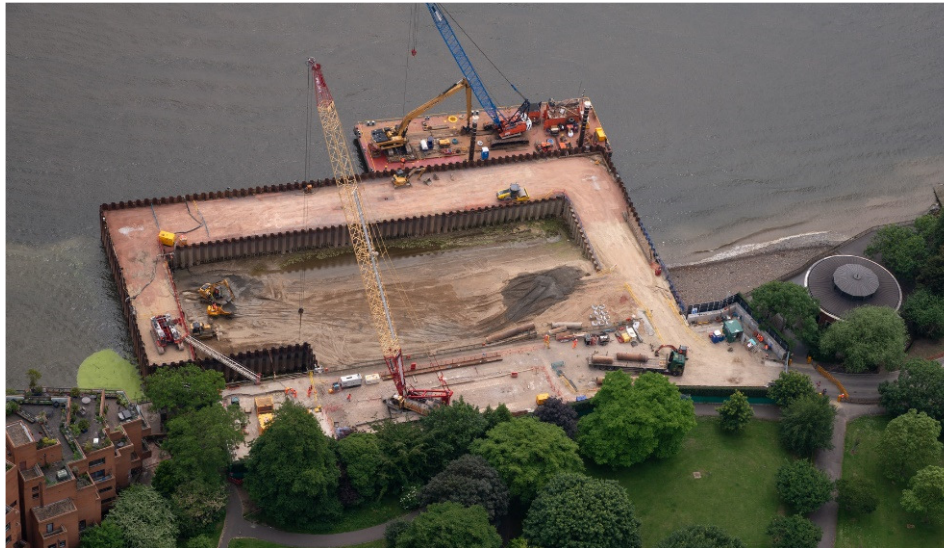
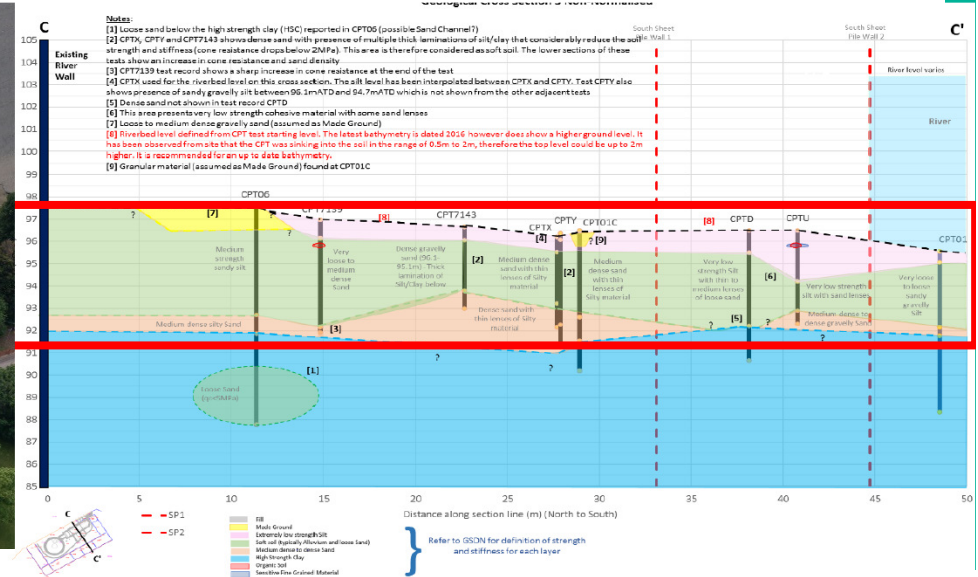
- Sheet pile deflection observed during twin wall backfilling operations
- Campaign of >50 CPTs and >15 BHs in the cofferdam footprint undertaken
- Significant variation of material type laterally & vertically across footprint
- Presence and variation in thickness of extremely low strength alluvial silt / clay (1.5 to 6m thick). c' of between 0-2kPa. C_u of 1-20kPa. Bulk density 10-20kN/m².
- Compressible material - > potential for differential loading on temporary & permanent works and differential settlement
- Variation or even absence of RTD thickness
- Lower than expected strength at the top of the Lambeth Group cohesive layer.
- Root cause = historic channel feature entering the foreshore from the NE of the cofferdam and trending S across footprint ? Possibly linked to a historic river tributary or sewer but nothing shown on maps >1746AD ?
