TBM excavation in contaminated ground - Innovation at the service of the Cityringen Metro

George Kafantaris
Technical & Design Director

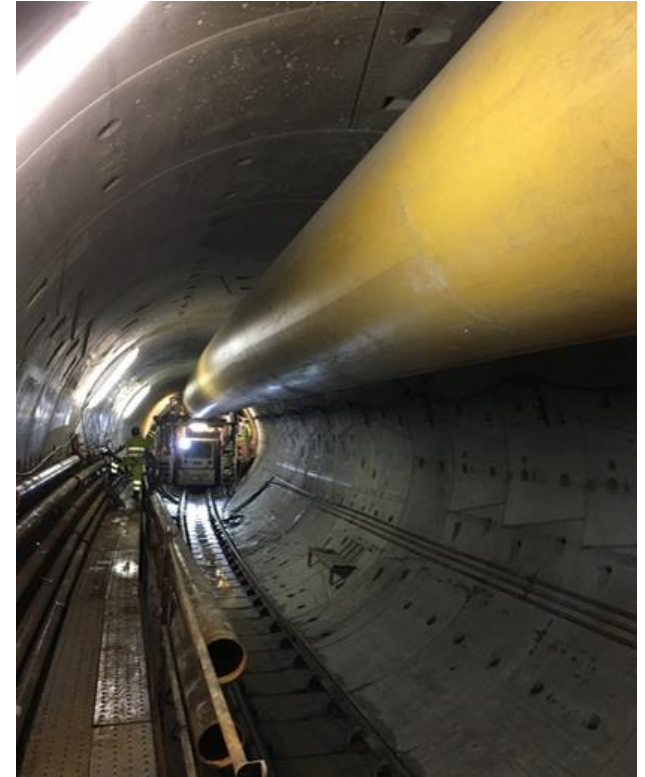
Areas of high risk for benzene release, from the excavation face and up to the portal:

- Excavation chamber
- Screw conveyor discharge
- Back-up belt conveyor
- Service train muck boxes

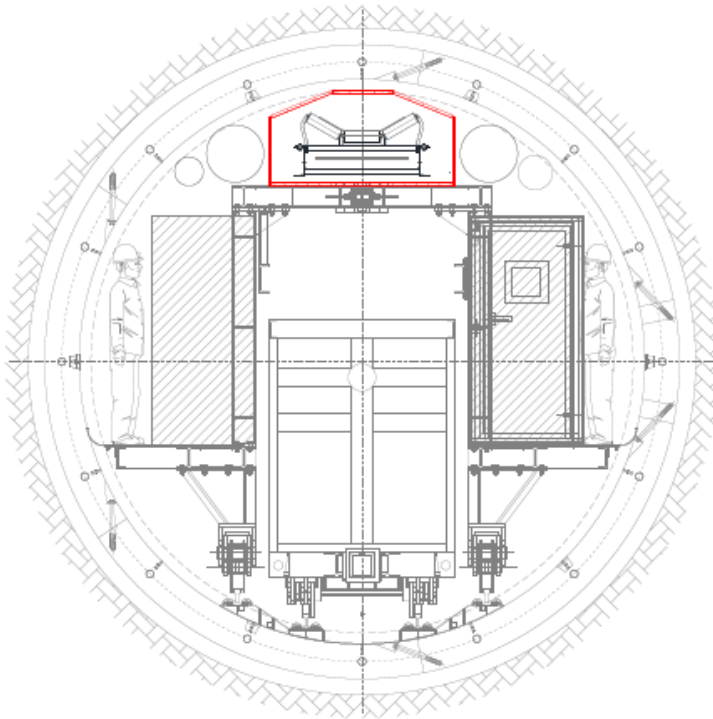
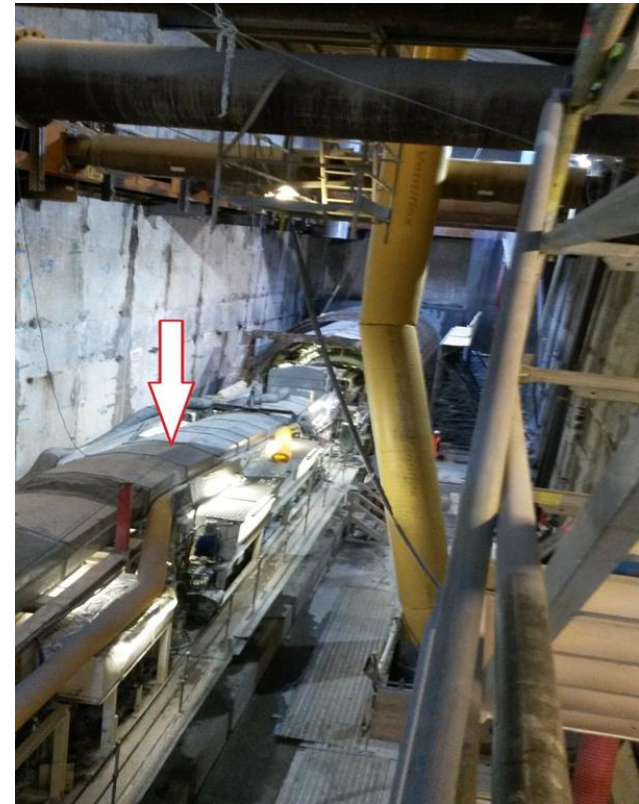
1. Sealed enclosure of the conveyor belt along the entire back-up

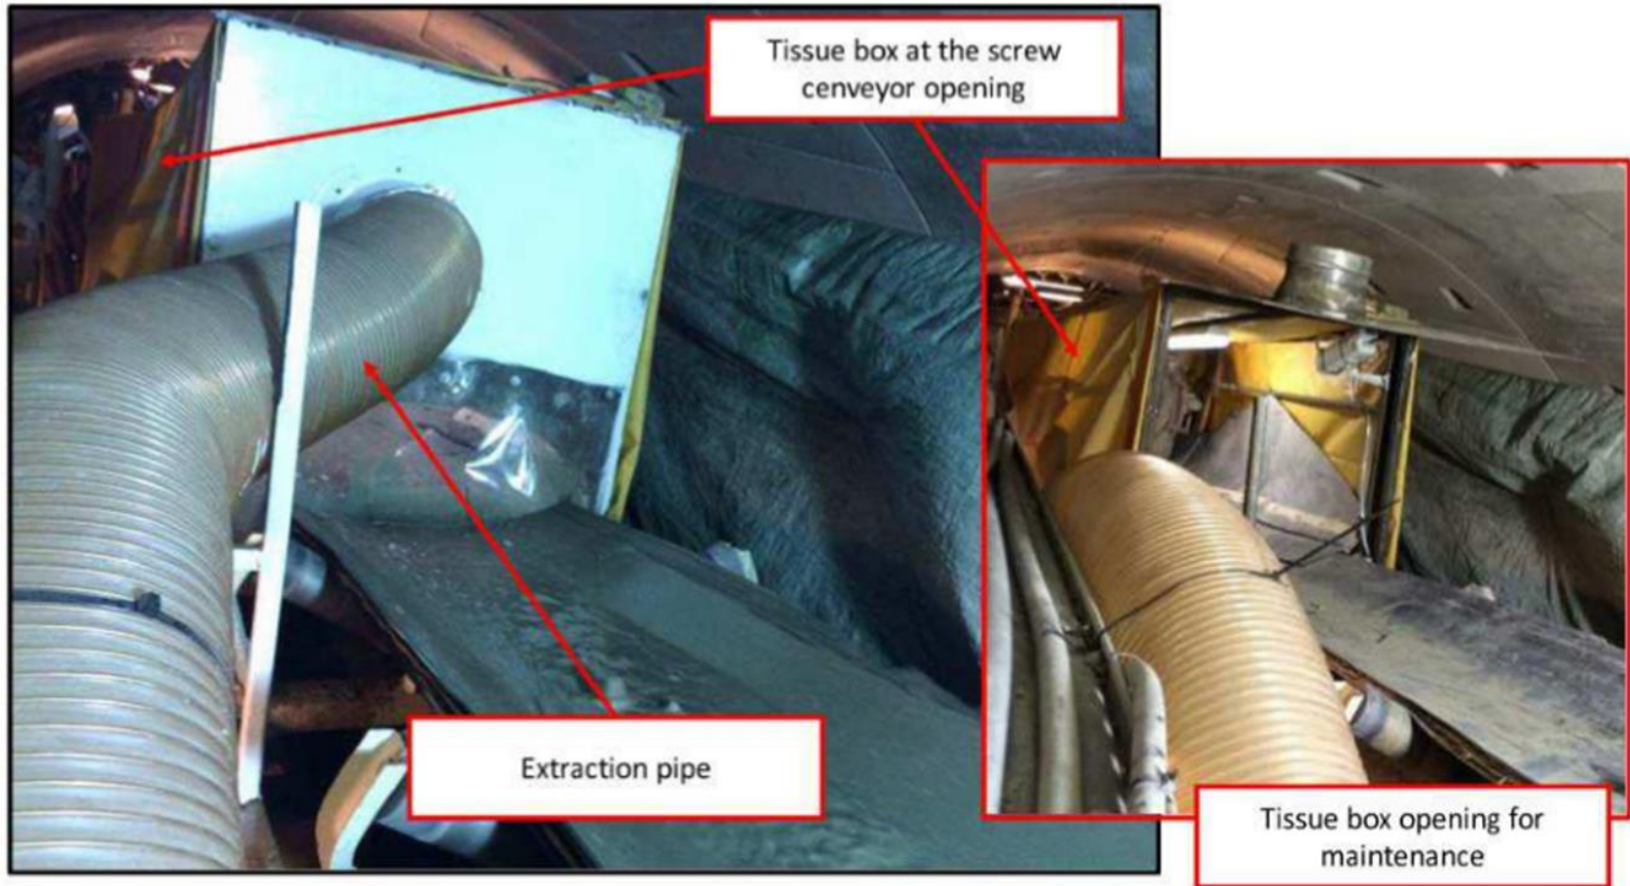
3. Fume extraction at the screw conveyor discharge point as well as the erector

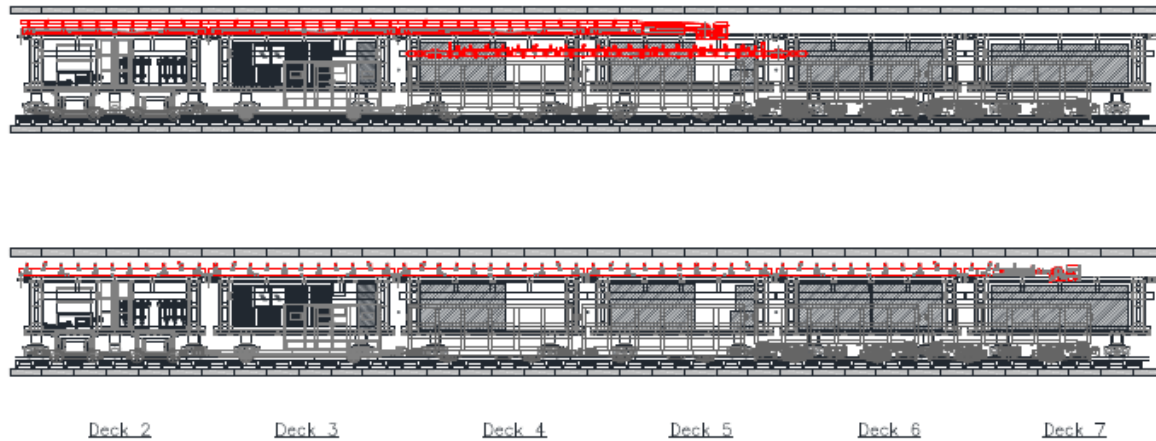
4. Extension of belt conveyor to eliminate mobile/reversible parts

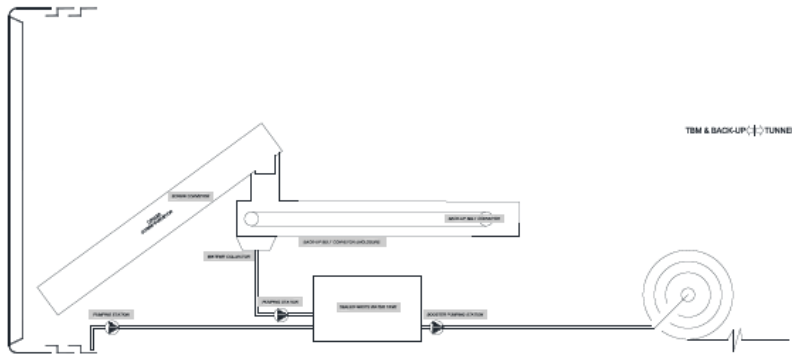
5. Water collector at the conveyor belt sealed enclosure connected with sealed tank

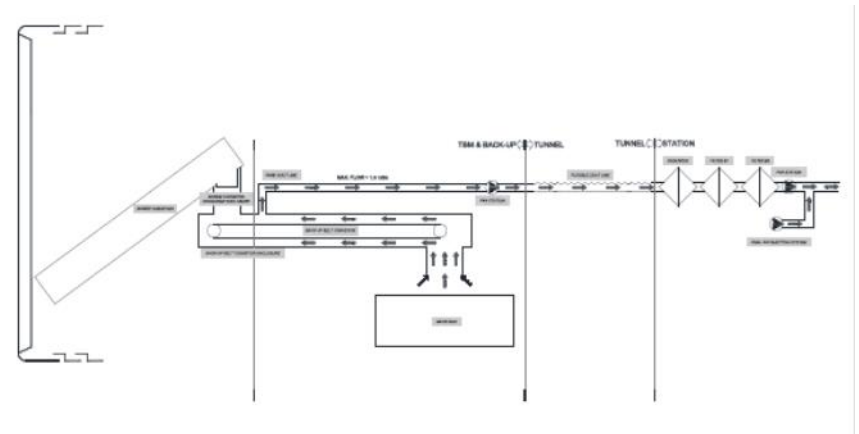
6. Forced air extraction along the covered/sealed conveyor belt

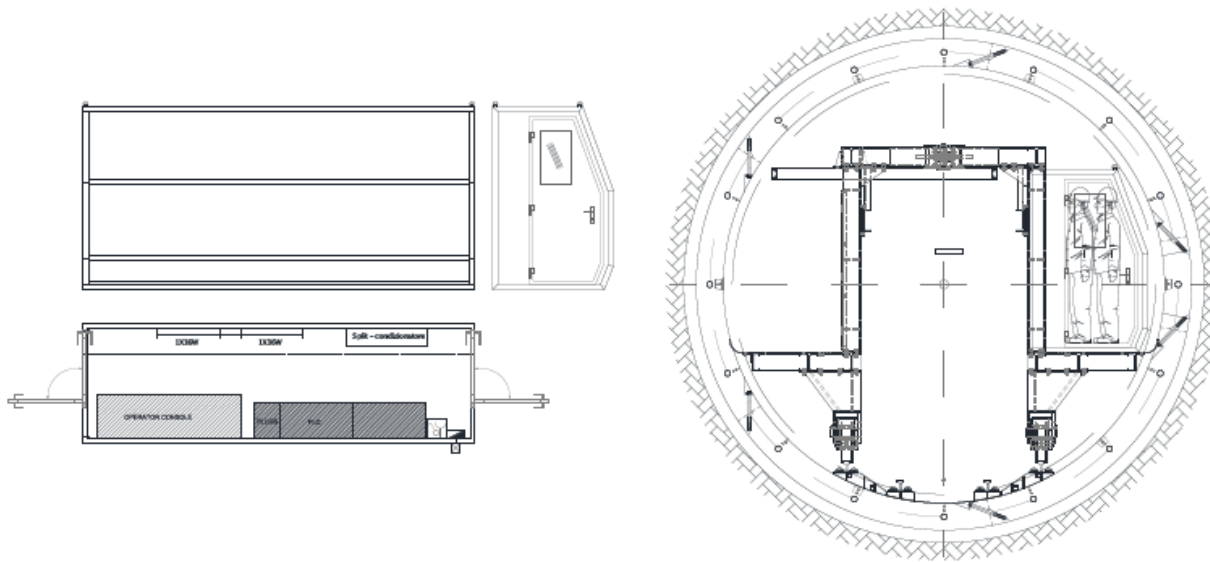
7. Sealed TBM control cabin

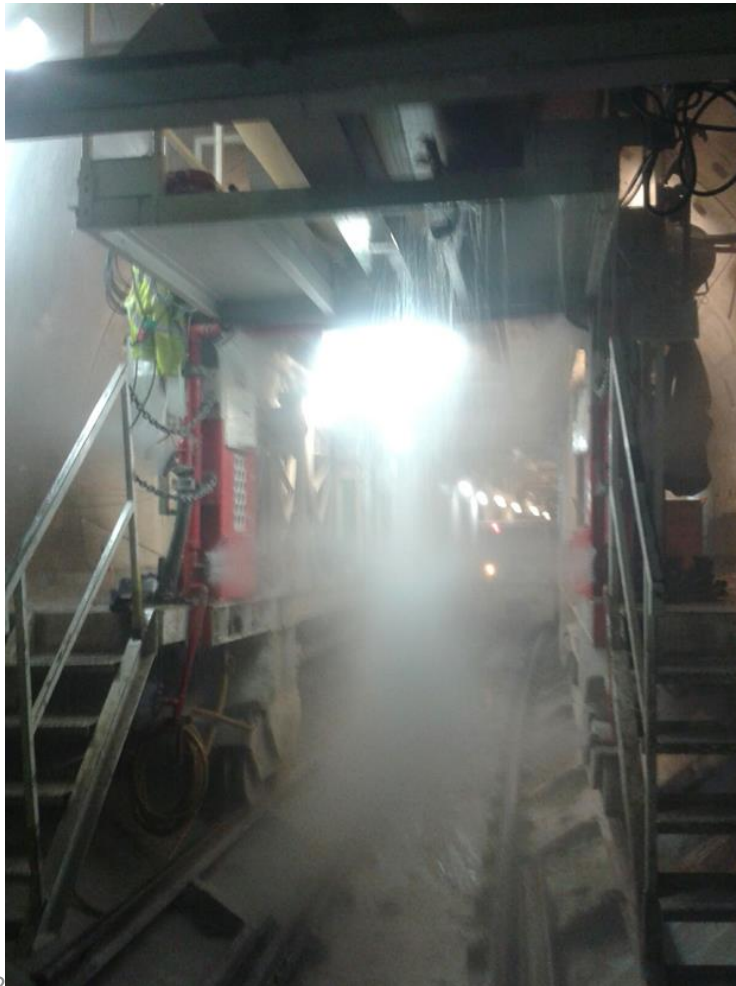
8. Fire retardant and foam sprinkler system on top of the muck boxes

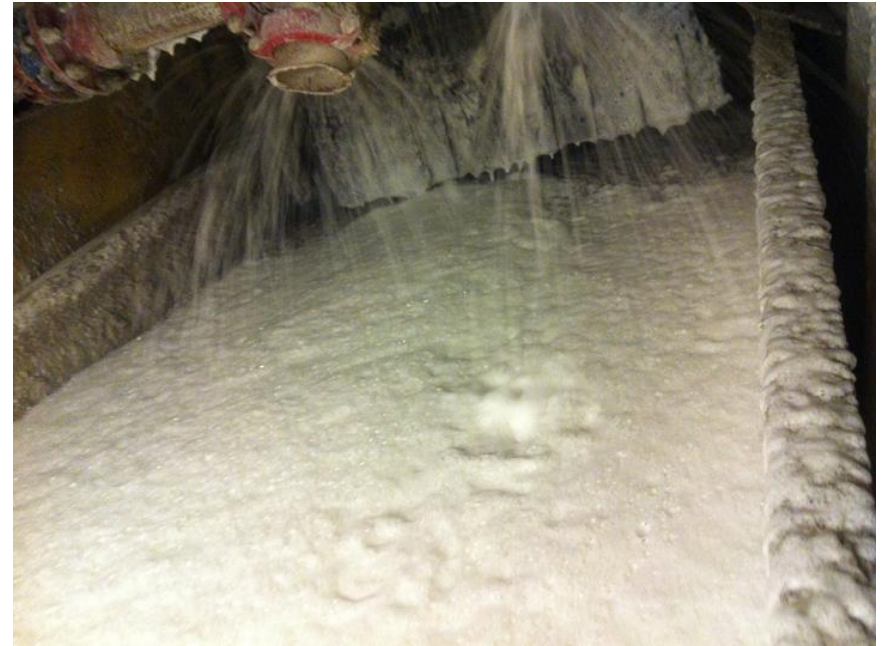
9. Muck box covering system immediately after loading

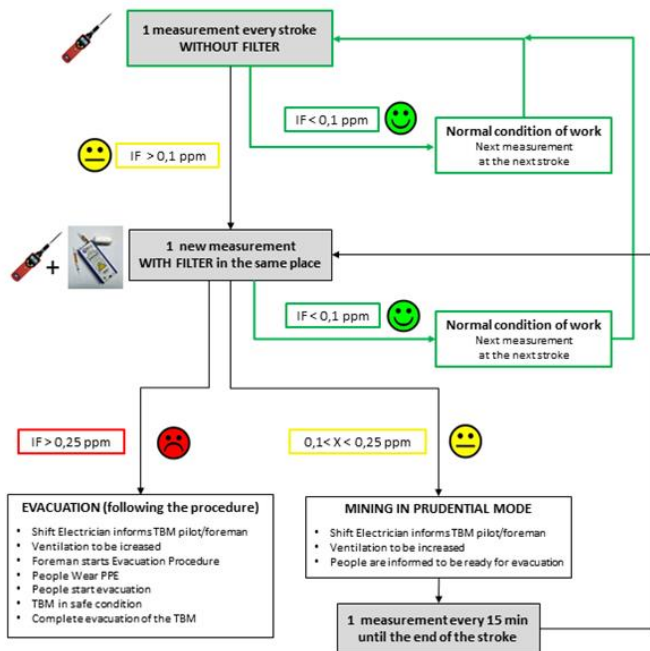
MONITORING PLAN FOR BENZENE (STRETCH SBV – KH)

Benzene detected concentration	Frequency of measurement
$x < 0,1$ ppm	1 reading every stroke (that means every 1.4m of excavation)
$0,1 \text{ ppm} < x < 0,25$ ppm	1 reading every 15 min (until the end of the subjected stroke)
$x > 0,25$ ppm	EVACUATION

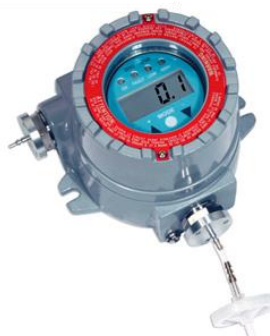
BENZENE READINGS ON TBM 4 SBV to SBV

DATE	TIME	ERECTOR	DISCHARGE POINT	BACK OF TBM	NAME OF PERSON READING
12/12/14	12:30	0,00	0,00	0,00	Paul Evans
12/12	14:30	0,00	05,53	5,10	PAUL EVANS
12/12	15:00	0,00	0,00	0,00	PAUL EVANS
12/12	15:00	0,00	0,00	0,00	PAUL EVANS
12/12/14	15:15	0,00	0,00	0,00	FRANCESCO CURATO
12/12/14	15:30	0,00	0,00	0,00	FRANCESCO CURATO
12/12/14	17:15	0,00	0,00 L 0,00 R	0,05	FRANCESCO CURATO
12/12/14	17:15	0,00	0,00	0,05	FRANCESCO CURATO
12/12/14	19:00	0,00	0,00	0,00	FRANCESCO CURATO
12/12/14	19:50	0,65	2,60	1,20	FRANCESCO CURATO
12/12/14	20:30	0,00	0,00	0,00	FRANCESCO CURATO
12/12/14	21:00	0,00	0,00	0,00	FRANCESCO CURATO

* ~~EVACUATED~~ TBM. IN THE STATION SBV
 ** THE TBM WAS SAFE TO BE E.
