Geotechnical Challenges of TTEAS

Chambers Wharf - Panel 15 Collapse & Recovery Works

Chambers Wharf – Panel 15 – 9th March 2018

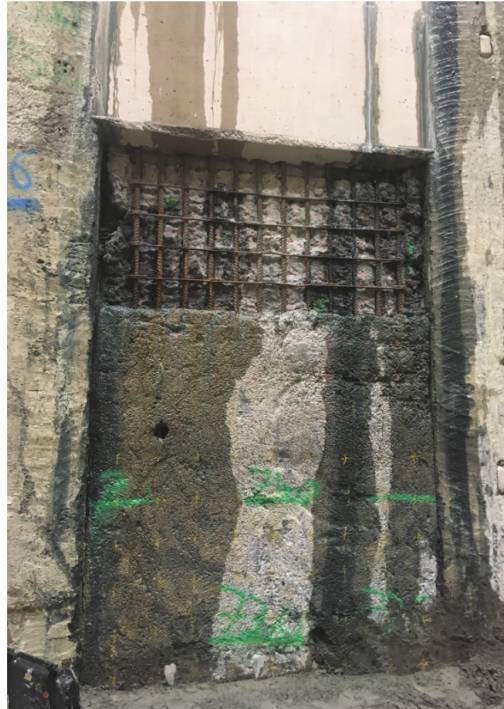
Infilled concrete at
73mATD

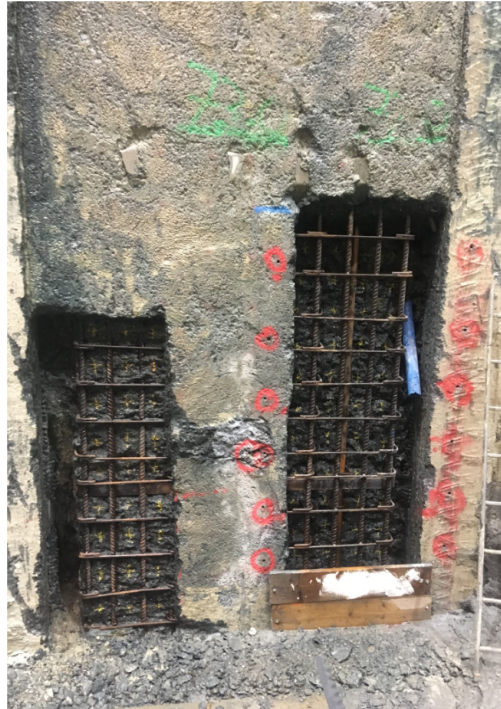
Infilled concrete at
71.5mATD

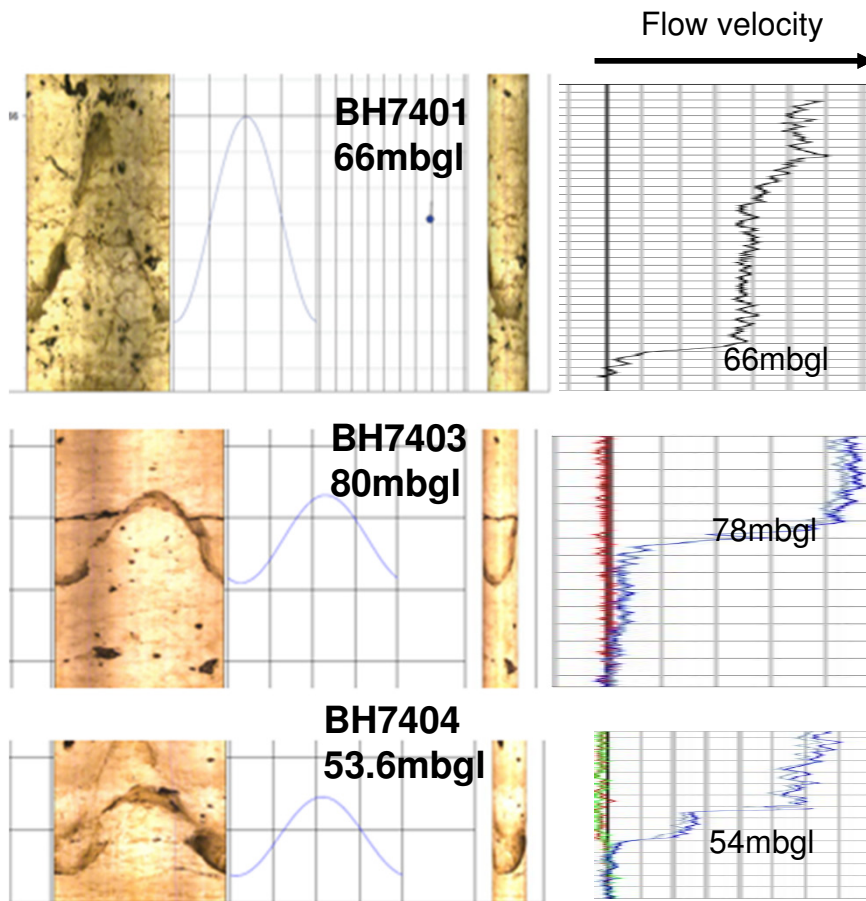
Similar yield indicating interception of the same hydraulic feature.

Similar orientations in depth range of fracture projection.

Drilling flush losses and packer testing results suggested higher flow zones but not conclusive.

Pumped flowmeter testing indicated 90% of the pumped flow being supplied by the fissure location (velocity reduction)

Packers and drilling flush were a guide to the apparent fissure location but not conclusive – pumped flow instrumental in defining flow horizon.

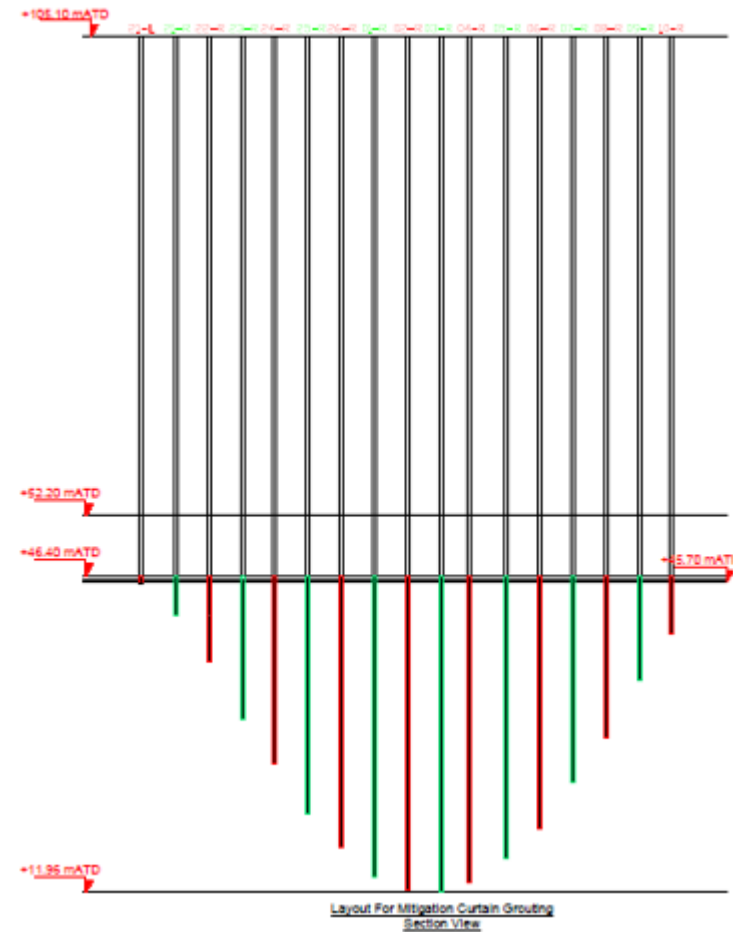
Post diaphragm wall validation

- Reservation tubes within cages utilised to drill chalk below the Dwall toe.
- Offset across the fissure confirmed at ~1m.
- Effectiveness of grouting assessed through identification of fissure infill? **To be investigated...**
